# POWER STEERING CAP'S A REAL MISHAP!

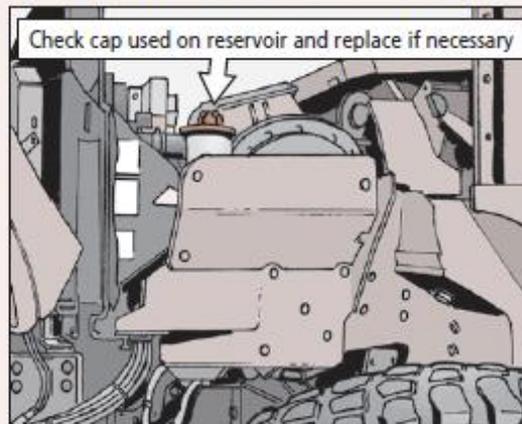
The culprit is usually the vehicle's original power steering reservoir cap, NSN 2590-01-556-5316. It's a known leaker.

To stop fluid loss, replace the old cap with a new style cap. The new cap, NSN 6680-20-006-4251, has three baffles on its dipstick that keep fluid from seeping past the cap.

So eyeball the cap you have on your MaxxPro. If it's the old-style cap, replace it now.
