NOT SEEING IS BELIEVING

MAINTAIN WITH EXTREME CARE

AFES Safety Wire Maintenance

DON'T HALF STEP ON HALFSHAFT CHECK

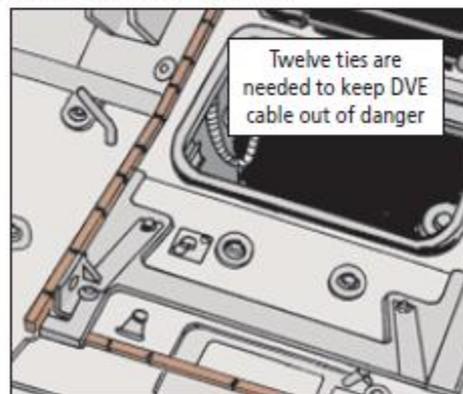
Broken or missing ties let the cable escape from the channel guide. It won't be long before the cable gets caught in one or both of the two hatches.

Crewmen, take a quick look at the cable ties as part of your before-operation PMCS. There should be a total of 12 ties, each spaced approximately four inches apart. Replace any that are broken or missing with NSN 5975-00-899-4606. That NSN brings 100 new cable ties.

Mechanics, if you have to replace a damaged DVE cable, don't forget to secure the new one with cable ties. Otherwise, you'll soon be replacing the cable again.

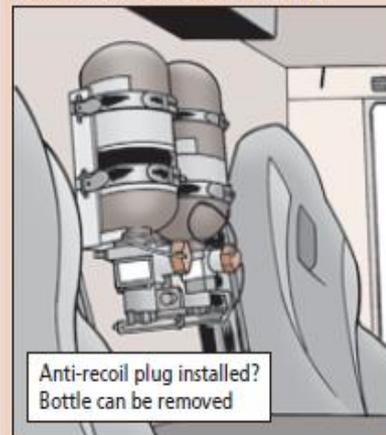
- Never remove the fire bottle assembly from its mount until you've installed the anti-recoil plug. Without the plug, an accidental discharge can turn an unsecured bottle into a dangerous rocket bouncing around the insides of your vehicle. The anti-recoil plug controls the discharge by safely directing the suppression agent through very small ports instead of the AFES nozzle.

The anti-recoil plug is attached to each fire bottle by a short lanyard. Don't remove the bottle if the plug's missing or if the lock pin isn't installed on the manual discharge lever. Report it.

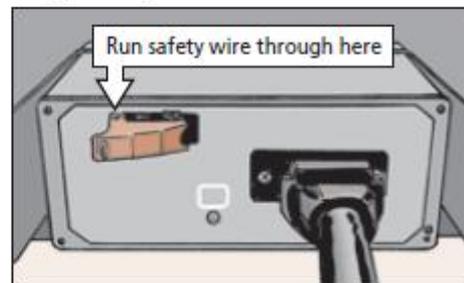
You probably know by now that the manual release switch on your up-armored HMMWV's automatic fire extinguishing system (AFES) has a safety wire. But you might not know there are no procedures to replace the switch guard safety wire or to inspect it for accountability. And the safety wire isn't shown in TM 9-2320-387-10 or TM 9-2320-387-24P!

TM 9-2320-387-10 and TM 9-2320-2320-387-24P will be updated to include safety wire PMCS information. But until that happens, safety-wire the manual release switch guard in the down or guarded position on the AFES, if it isn't already. Just get the anti-pilferage seal (safety wire kit), NSN 5340-00-835-9815, which includes the wire and seal, and follow these instructions:

1. Ensure the switch guard is in the down or guarded position.
2. Insert the safety wire through the hole in the switch guard and into the lower tab below the switch.
3. Insert both ends of the wire into the safety seal. Pull the wire tightly to ensure the switch guard is secured in the down or guarded position.
4. Use a crimping tool to compress the seal.
5. Cut any excess wire from the seal.

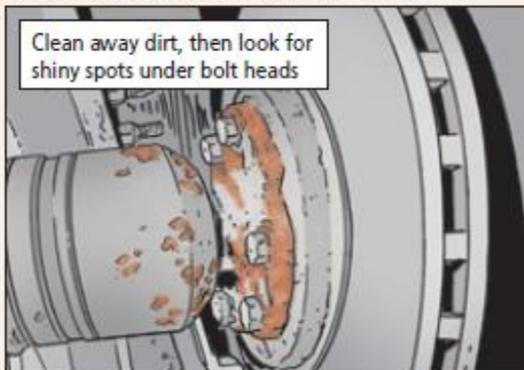
Clean away dirt, then look for shiny spots under bolt heads

Once you've cleaned away dirt and mud, it's easy to see if the bolts that hold the halfshaft to the rotor are loose. Just look for shiny spots under the bolt heads.

If you find a loose bolt, replace both the lock washer, NSN 5310-01-457-3292, and the bolt, NSN 5306-01-185-7048. Dip the bolt in sealing compound, NSN 8030-01-171-7628, before installing it to help keep it tight. Then torque the bolt to 51 lb-ft.

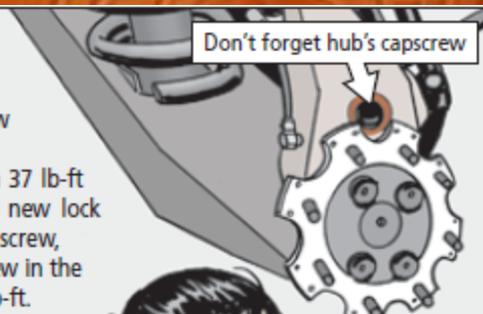
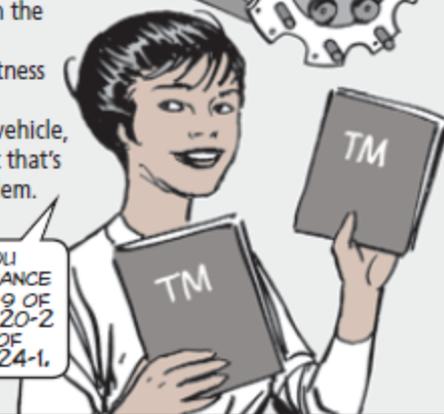
Don't forget hub's capscrew

It's not so easy to check the cap screw in the hub. You must first remove an access plug to get to the screw, then use a torque wrench to tell if the screw is loose.

If the screw moves before you reach 37 lb-ft of torque, it's loose. Replace it with a new lock washer, NSN 5310-00-011-5093, and cap screw, NSN 5305-00-068-0511. Dip the new screw in the sealing compound and torque it to 37 lb-ft.

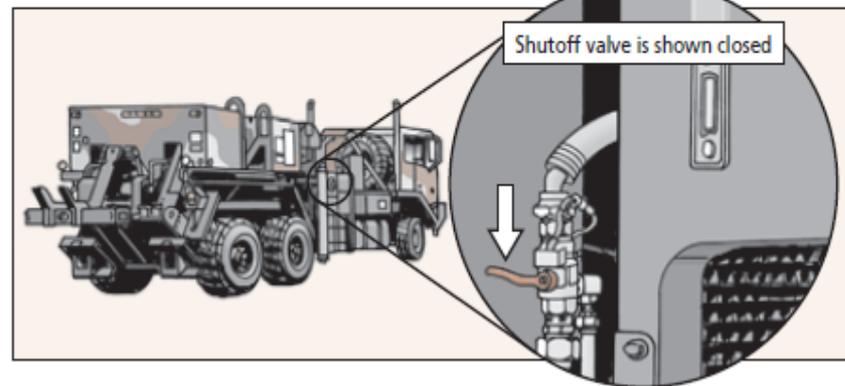
The artwork for the Underlift Assembly Operation in WP 0037 00-01 of TM 9-2320-392-10-1 (Mar 09) and IETM 9-2320-391-10-1/2 (Mar 09) is incorrect. The shutoff valve is shown in the closed position but the callout says the valve is in the open position.

The written instructions for this task correctly state that the valve must be in the open position. However, because the artwork is wrong, some users have mistakenly placed the valve in the closed position, damaging the boom winch.

So disregard the artwork showing the position of the shutoff valve for this procedure. The valve is open when the handle is straight down *in line* with the valve, *not* at a right angle. Make sure the valve is in the open position when performing this task. And make a note in your paper TM.

The valve should only be closed for maintenance purposes. Secure the valve in the open position using a zip tie, such as NSN 5975-01-034-5871. Any zip tie will do, and you should be able to find them in your motor pool.

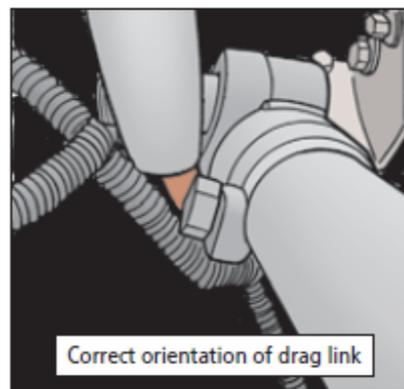
The next time you order the drag link, NSN 2530-01-377-3127, PN 12418103-002, you'll see that it looks different. But the only difference is that there is an adjustable tie-rod end with a clamp on both ends now.

When you get the drag link with the new design, go ahead and adjust the tie-rod ends to match the same length of the drag link being replaced. Turn the steering wheel fully to the left, too. The drag link must be installed with the bend turning to the left to fit correctly. The clamp on the pitman arm side must have the bolt adjusted to the bottom side of the drag link with the bolt entering from left to right and the clamp 1 centimeter to the rear of the pitman arm. Then you won't have interference while turning the wheel.
