# Software Updates a Breeze on AKO

# HOW TO INSPECT BALL JOINTS!

# OIL OVER-FILLING FIX

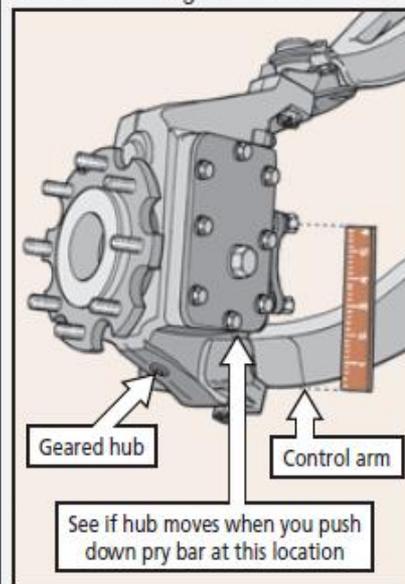
a. Mark a line across the head of the top bolt holding the steering arm cover. Make sure the mark is parallel to the lower control arm.

b. Put a pry bar between the cover control arm and geared hub.

c. Set a 6-in ruler upright between the lower control arm and the marked screw.

d. Push down the pry bar to try to move the hub.

e. Measure movement in the hub assembly. If movement is more than  $\frac{1}{8}$  inch, replace the lower ball joint.

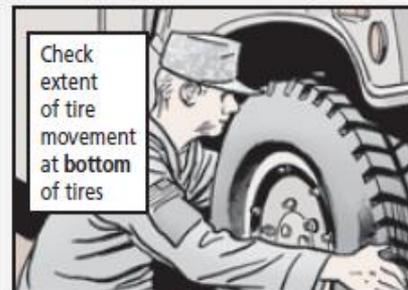
You can also check for looseness in the lower ball joints by grasping the bottom of tires and attempting to move tires in and out. If tire movement at the bottom outer edge of tires is  $\frac{1}{2}$  inch or more, replace the lower ball joints.

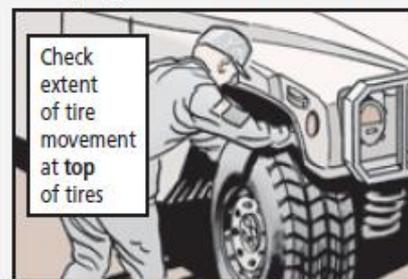
a. Check for looseness of upper ball joints by grasping the top of tires and attempting to move tires in and out.

b. Measure any movement at the top outer edge of tire. Replace upper ball joints if tire movement is  $\frac{3}{8}$  inch or more.

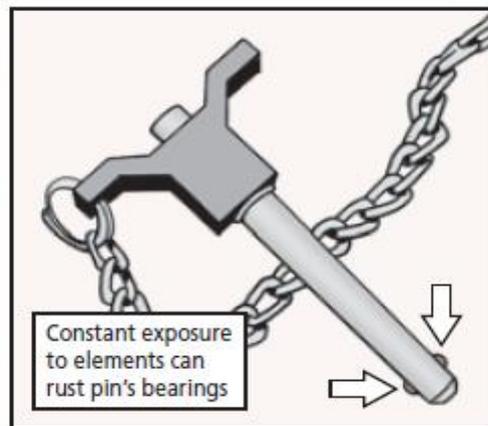
That's true of the retractable ball bearings on the HMMWV brush guard's quick-release pin, too. All that constant exposure to the elements eventually rusts the bearings in place.

Then you're stuck with a pin that won't release and a brush guard that can't be raised or lowered.

Keep the pin's bearings moving with a shot of lubricating spray, NSN 9150-00-458-0075, as required. Just give the ball bearings a squirt, then slide the pin in and out of the brush guard a few times to work in the lube.

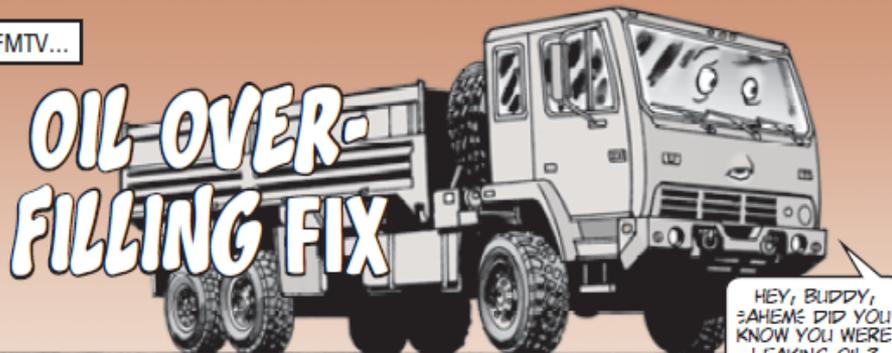
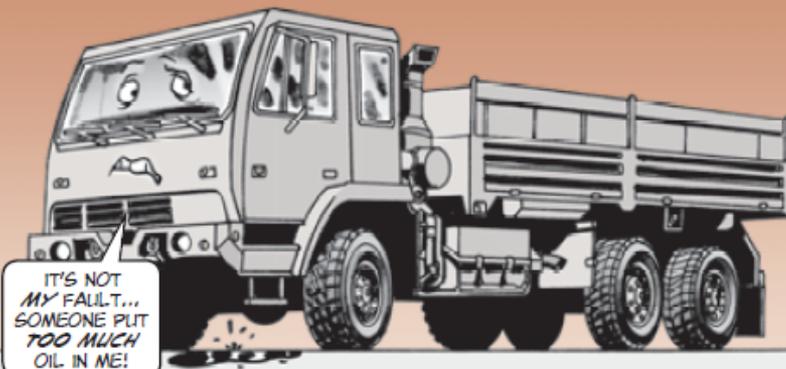
If your unit has FMTVs with serial number 100,001 or higher, listen up! Trucks equipped with C7 engines can experience oil blow-by problems due to overfilling.

Overfilling engines can blow the extra oil out of the engine breather tube. That's why Caterpillar and TACOM have decided to lower the engine oil levels in the C7 engine crankcases from 24 to 22 quarts. This should solve the problem.

During normal PMCS oil change intervals, or whenever needed, units can re-mark their current C7 dipsticks, NSN 6680-01-568-9447, PN 252-0507, to the new 22-qt range or purchase a new 22-qt dipstick, NSN 6680-01-568-9447, PN 348-6030. FMTV LTAS (long term armor strategy) trucks with serial number 705248 and above should already have this new dipstick. They were installed at the factory.

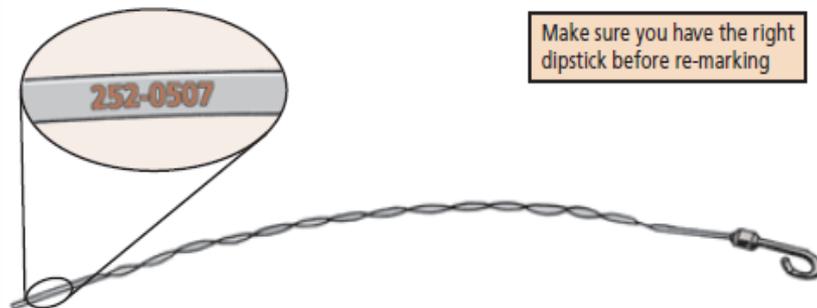
- After removing and wiping the dipstick, insert and remove it and observe the new oil "Full" level. If the oil level does not line up with the original dipstick "Full" range marks, etch a new "Full" line on the backside of the dipstick.

— Caution: Before re-marking your dipstick, ensure your original dipstick has part number 252-0507 stamped on the lower end.

- Note: Due to unknown quantities of residual oil draining back from engine components and cavities, re-marking of the dipstick may not always be necessary.
- If a new "Full" line was made, measure 1/2 inch down from that line and etch a new "Add" line.
- Using a suitable tool, make the old range markings on the front side of the dipstick unreadable.
- If the dipstick has been modified, keep future oil capacity levels between the new "Full & Add" marks made on the backside.
