HEMTT -A4s...

ROUTING HOSE WRONG MEANS TROUBLE!

...TACOM MAINTENANCE ADVISORY (MA) MESSAGE 10-015!

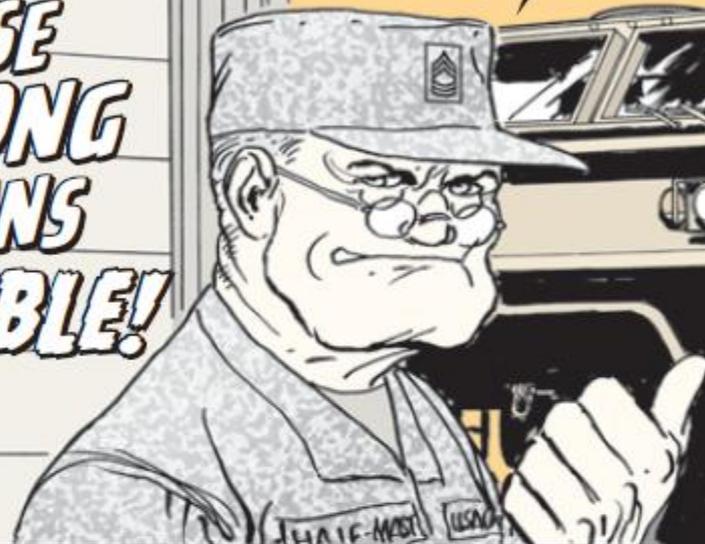
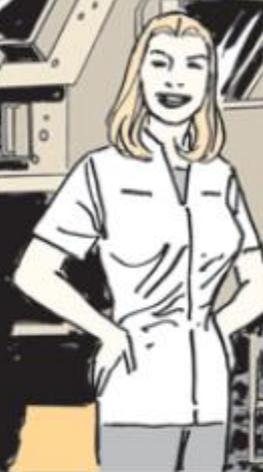
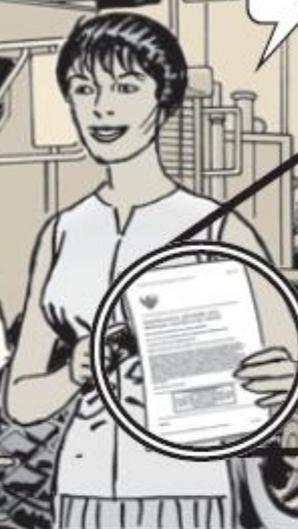
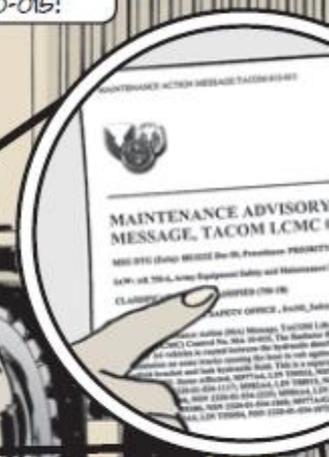
MA 10-015 SAYS THAT ON SOME HEMTT -A4 TRUCKS, THE HYDRAULIC DRAIN HOSE FROM THE RADIATOR FAN MOTOR MAY BE ROUTED INCORRECTLY, CAUSING THE HOSE TO WEAR AND EVENTUALLY LEAK.

The hose is behind the engine. It crosses over the transmission leading to the radiator fan motor to a T-fitting at the hydraulic reservoir. The hydraulic manifold is located on a bracket above the transmission. The hose is positioned above the hydraulic distribution manifold.

HEMTT -A4 operators should inspect the radiator fan motor's hydraulic drain hose for the installation position and for wear right away. The hose, NSN 4720-01-562-9248, is shown as Item 43 in Fig 381 of EM 0288, the IETM for the HEMTT -A4, and in the hydraulic schematic as line 2980. EM 0288 will be updated with the hose NSN at the next change. A field-level mechanic can replace or properly route the hose.

If the hose does not show wear, and is not routed beneath the distribution manifold, but still is not in the proper location above the manifold, just leave it alone for now. The contractor will re-route the hose to the correct position during installation of the production fix to HEMTT -A4s mentioned in TACOM SOUM 10-003.

Also, you may need extra slack to re-route an existing hose. Loosen the hose clamps and pull enough of the hose through to get the slack needed to route the hose above the distribution manifold. The drain hose can be zip-tied to the supply hose for the radiator hydraulic motor fan. This supply hose is line 2976 in the hydraulic schematic and comes out of a T-fitting at the front of the distribution manifold.

If wear causes you to order a replacement hose, use PMCS guidance to inspect your -A4 HEMTT hose daily for leaks while waiting for the part to arrive. Deadline the truck if you find class III leaks in the hydraulic drain hose.
