NOT SEEING IS BELIEVING

MAINTAIN WITH EXTREME CARE

AFES Safety Wire Maintenance

DON'T HALF STEP ON HALFSHAFT CHECK

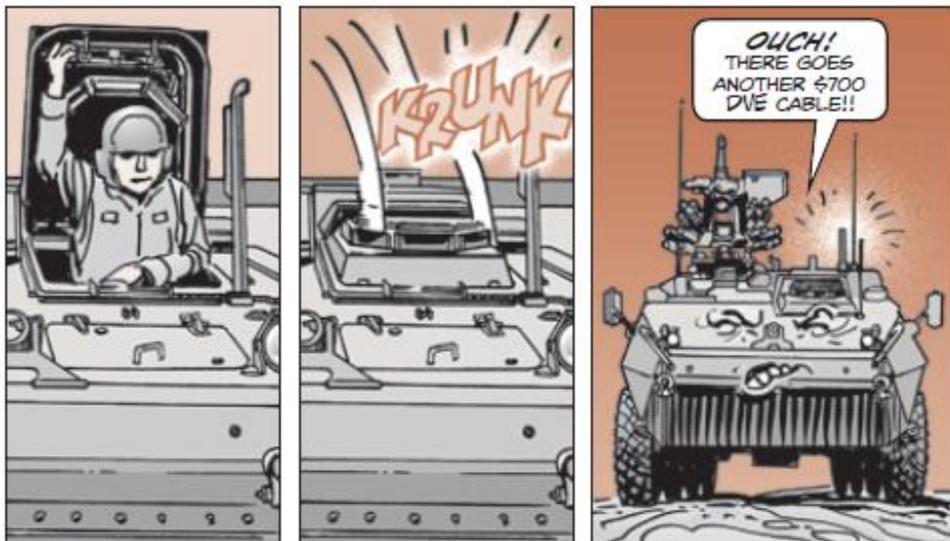
Believe it, crewmen. Just a few missing cable ties can leave your driver's vision enhancer (DVE) totally in the dark.

Those cable ties are used to hold the DVE cable inside a channel guide that runs from the DVE camera to the screen. The channel guide runs between the engine access and driver's hatches and then below the driver's hatch.

Broken or missing ties let the cable escape from the channel guide. It won't be long before the cable gets caught in one or both of the two hatches.

Crewmen, take a quick look at the cable ties as part of your before-operation PMCS. There should be a total of 12 ties, each spaced approximately four inches apart. Replace any that are broken or missing with NSN 5975-00-899-4606. That NSN brings 100 new cable ties.

Mechanics, if you have to replace a damaged DVE cable, don't forget to secure the new one with cable ties. Otherwise, you'll soon be replacing the cable again.

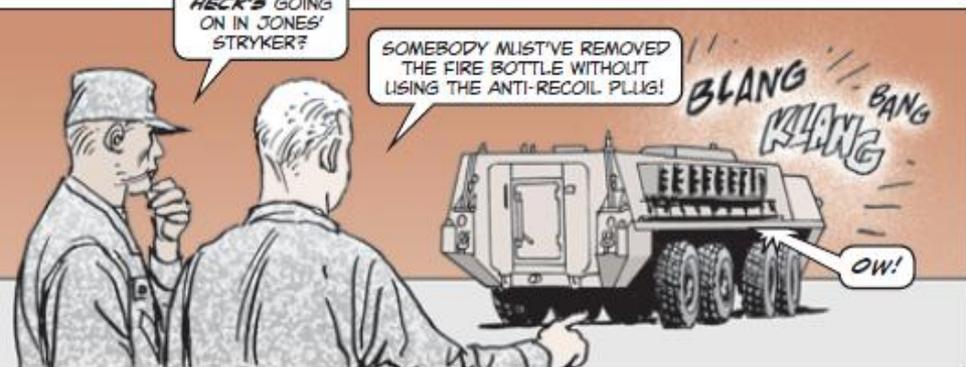
Pulling maintenance on your combat or tactical vehicle's automatic fire extinguisher system (AFES)? That's a good time to be alert and put on the kid gloves. AFES maintenance requires **EXTREME CAUTION!** You shouldn't be afraid of the equipment, but you should respect it!

You can be seriously injured—even killed—if procedures aren't followed and an extinguisher bottle discharges unexpectedly during maintenance.

- Never remove the fire bottle assembly from its mount until you've installed the anti-recoil plug. Without the plug, an accidental discharge can turn an unsecured bottle into a dangerous rocket bouncing around the insides of your vehicle. The anti-recoil plug controls the discharge by safely directing the suppression agent through very small ports instead of the AFES nozzle.

The anti-recoil plug is attached to each fire bottle by a short lanyard. Don't remove the bottle if the plug's missing or if the lock pin isn't installed on the manual discharge lever. Report it.

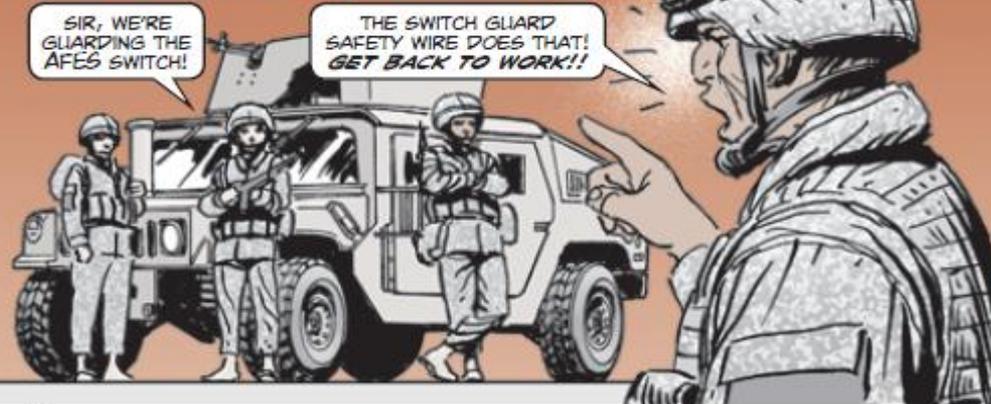
You probably know by now that the manual release switch on your up-armored HMMWV's automatic fire extinguishing system (AFES) has a safety wire. But you might not know there are no procedures to replace the switch guard safety wire or to inspect it for accountability. And the safety wire isn't shown in TM 9-2320-387-10 or TM 9-2320-387-24P!

TM 9-2320-387-10 and TM 9-2320-2320-387-24P will be updated to include safety wire PMCS information. But until that happens, safety-wire the manual release switch guard in the down or guarded position on the AFES, if it isn't already. Just get the anti-pilferage seal (safety wire kit), NSN 5340-00-835-9815, which includes the wire and seal, and follow these instructions:

1. Ensure the switch guard is in the down or guarded position.
2. Insert the safety wire through the hole in the switch guard and into the lower tab below the switch.
3. Insert both ends of the wire into the safety seal. Pull the wire tightly to ensure the switch guard is secured in the down or guarded position.
4. Use a crimping tool to compress the seal.
5. Cut any excess wire from the seal.

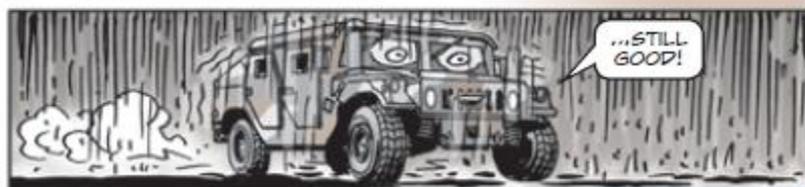
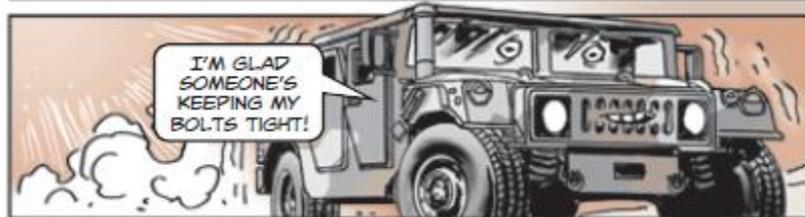
If a halfshaft flies loose, it can take out the brake lines and coolant tube, and cause engine failure. So don't half step when checking halfshaft bolts for tightness.

Once you've cleaned away dirt and mud, it's easy to see if the bolts that hold the halfshaft to the rotor are loose. Just look for shiny spots under the bolt heads.

If you find a loose bolt, replace both the lock washer, NSN 5310-01-457-3292, and the bolt, NSN 5306-01-185-7048. Dip the bolt in sealing compound, NSN 8030-01-171-7628, before installing it to help keep it tight. Then torque the bolt to 51 lb-ft.

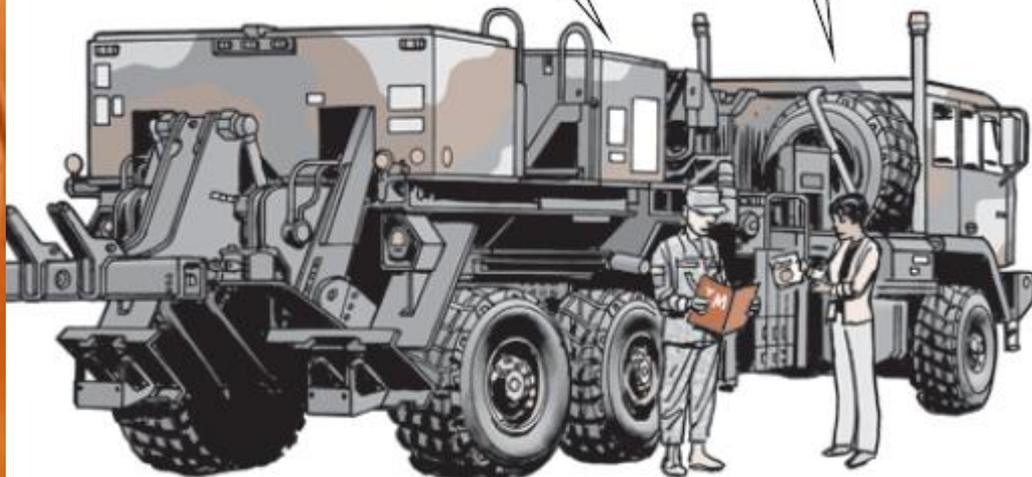
The artwork for the Underlift Assembly Operation in WP 0037 00-01 of TM 9-2320-392-10-1 (Mar 09) and IETM 9-2320-391-10-1/2 (Mar 09) is incorrect. The shutoff valve is shown in the closed position but the callout says the valve is in the open position.

The written instructions for this task correctly state that the valve must be in the open position. However, because the artwork is wrong, some users have mistakenly placed the valve in the closed position, damaging the boom winch.

So disregard the artwork showing the position of the shutoff valve for this procedure. The valve is open when the handle is straight down *in line* with the valve, *not* at a right angle. Make sure the valve is in the open position when performing this task. And make a note in your paper TM.

The valve should only be closed for maintenance purposes. Secure the valve in the open position using a zip tie, such as NSN 5975-01-034-5871. Any zip tie will do, and you should be able to find them in your motor pool.

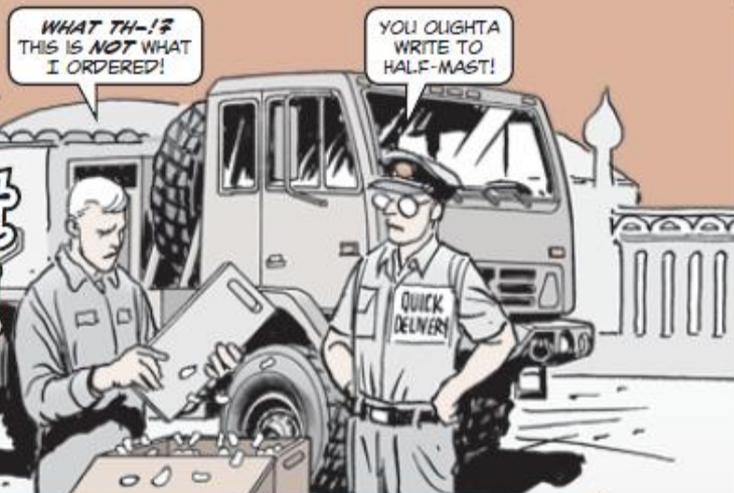
My unit is deployed to Southwest Asia. One of our M10BBA1s short-circuited and cooked the green PDU circuit panel on the passenger side of the dashboard.

When ordering the part from TM 9-2320-366-24P, I ended up with the wrong part—a black, plastic board that doesn't even fit on the truck!

You bet. Order the next higher assembly, the power distribution panel's printed circuit board (with fuses), NSN 5998-01-532-1911, if your A1 truck's serial number is within the 11,438 – 99,999 range.

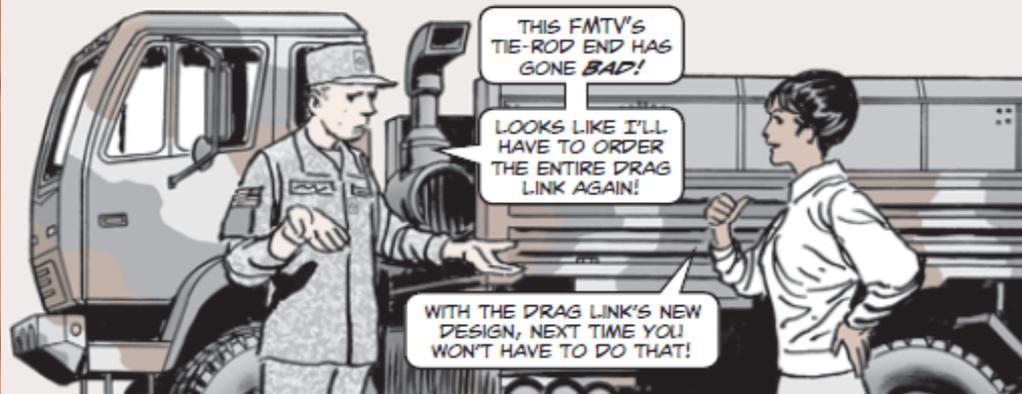
Change is good, if something positive comes out of it. And the engineers at TACOM decided that a design change was good for the drag link in your 2½- and 5-ton FMTV trucks. The new design stops you from having to order the entire drag link when a tie-rod end goes bad.

The next time you order the drag link, NSN 2530-01-377-3127, PN 12418103-002, you'll see that it looks different. But the only difference is that there is an adjustable tie-rod end with a clamp on both ends now.

When you get the drag link with the new design, go ahead and adjust the tie-rod ends to match the same length of the drag link being replaced. Turn the steering wheel fully to the left, too. The drag link must be installed with the bend turning to the left to fit correctly. The clamp on the pitman arm side must have the bolt adjusted to the bottom side of the drag link with the bolt entering from left to right and the clamp 1 centimeter to the rear of the pitman arm. Then you won't have interference while turning the wheel.

There's a CAUTION in the work package that tells you the tie-rod end must be installed toward the rear of the vehicle. Ignore that because now both ends have a tie-rod end. This caution will be deleted in a future TM change.
