# Software Updates a Breeze on AKO

# HOW TO INSPECT BALL JOINTS!

# OIL OVER-FILLING FIX

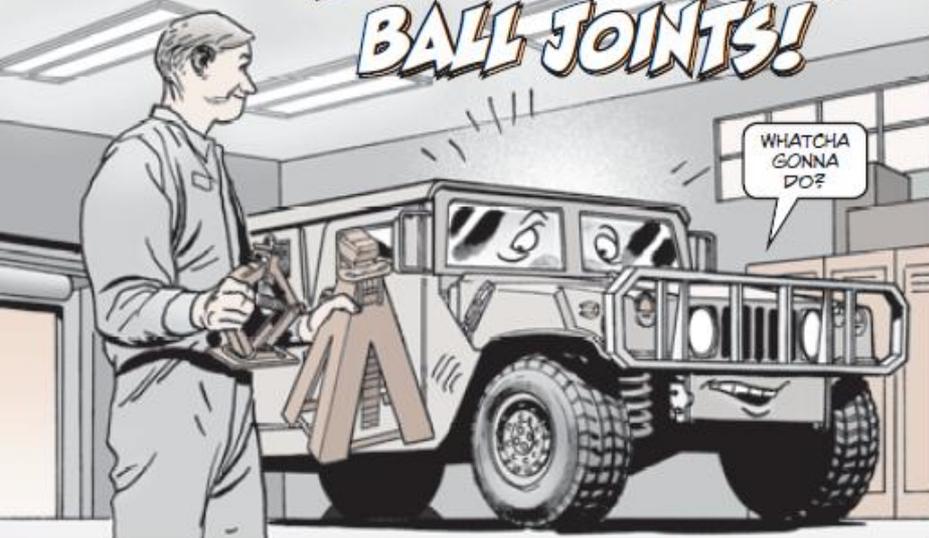
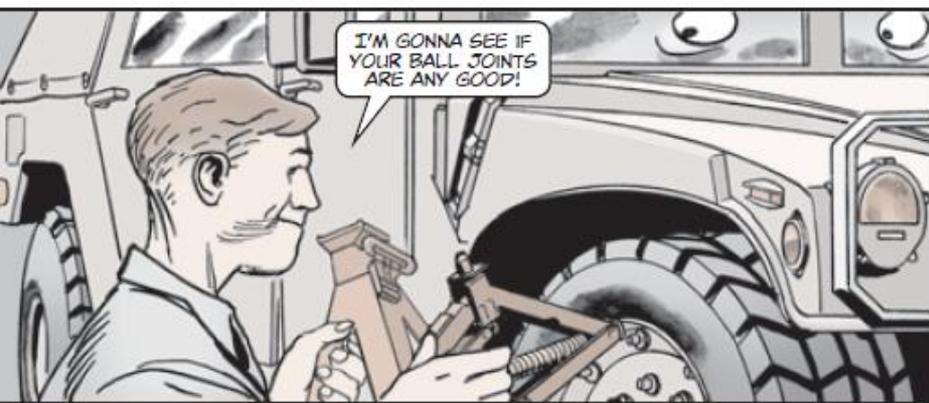
A mechanic recently came to me and said he needed to replace his HMMWV's ball joints. I asked him, "Why are you replacing them? What makes you think they are bad?" To my surprise, he answered, "Someone told me if I could move the halfshaft with my hand it was no good."

Now, you and I both know that's not the right answer! Can PS please clarify the correct way to inspect HMMWV upper and lower ball joints? I'm concerned that money is wasted when good parts are mistakenly replaced.

The -10 tells you to visually check halfshaft CV boots and ball joint boots for presence, rips, tears or cuts.

The -20 tells you to check for proper operation of ball joints using these steps:

e. Measure movement in the hub assembly. If movement is more than  $\frac{1}{8}$  inch, replace the lower ball joint.

You can also check for looseness in the lower ball joints by grasping the bottom of tires and attempting to move tires in and out. If tire movement at the bottom outer edge of tires is  $\frac{1}{2}$  inch or more, replace the lower ball joints.

b. Measure any movement at the top outer edge of tire. Replace upper ball joints if tire movement is  $\frac{3}{8}$  inch or more.

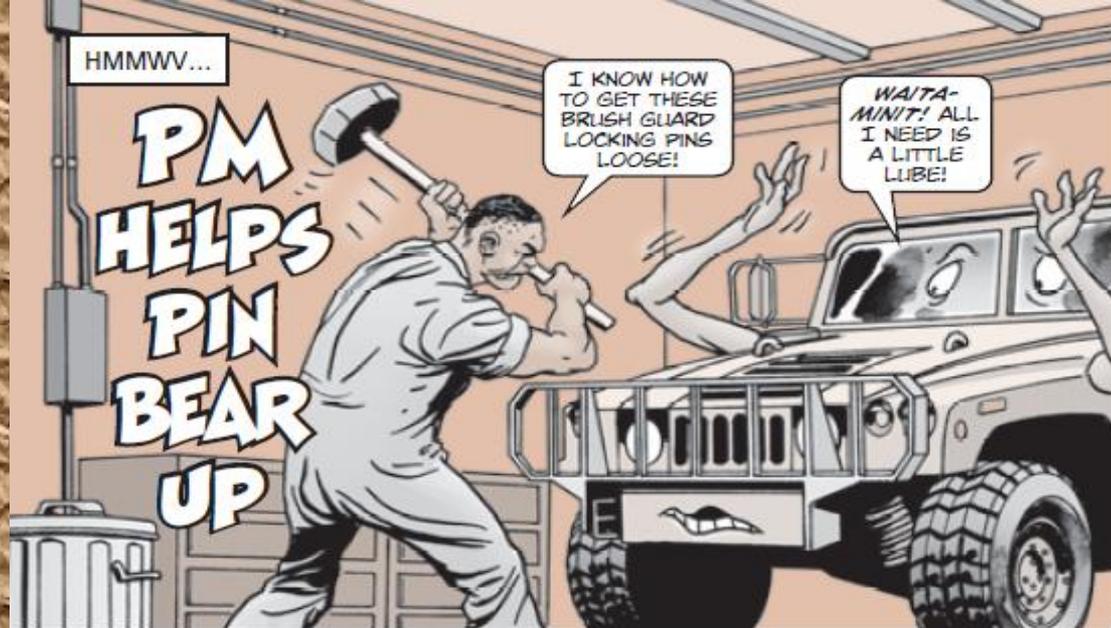
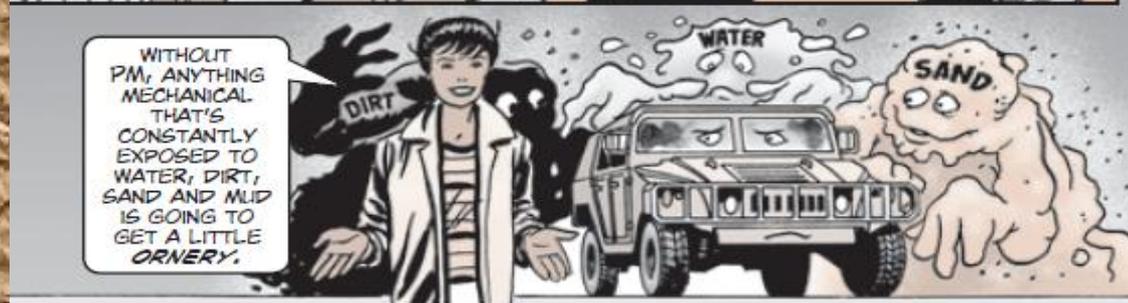
That's true of the retractable ball bearings on the HMMWV brush guard's quick-release pin, too. All that constant exposure to the elements eventually rusts the bearings in place.

Then you're stuck with a pin that won't release and a brush guard that can't be raised or lowered.

Keep the pin's bearings moving with a shot of lubricating spray, NSN 9150-00-458-0075, as required. Just give the ball bearings a squirt, then slide the pin in and out of the brush guard a few times to work in the lube.

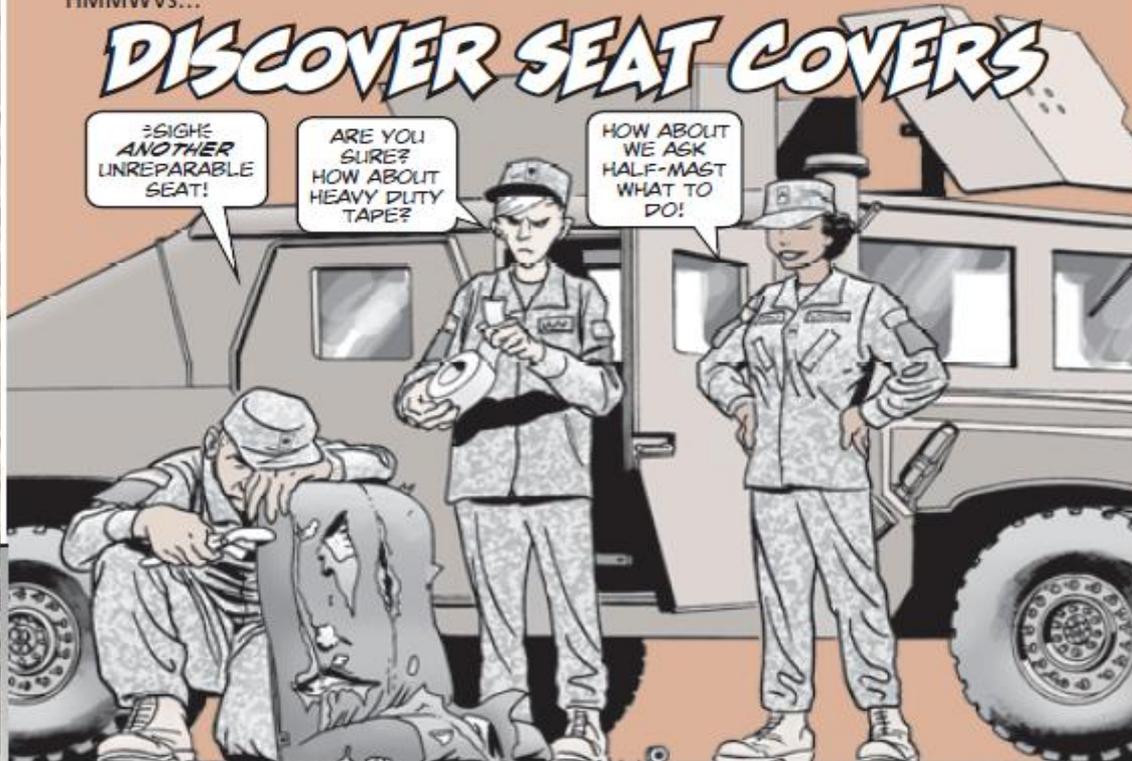
# DISCOVER SEAT COVERS

SIGH!  
ANOTHER  
UNREPAIRABLE  
SEAT!

Dear Half-Mast,  
Does a seat cover exist for M998A1s with bucket-type front seats? When the seats rip, it seems like we shouldn't have to replace the entire seat assembly! Is there a more economical fix?

There is! But since there's no NSN, you'll have to order directly from the vendor, Isringhausen, Inc.

Use CAGE code 62226 and the part numbers from this chart to order what you need:

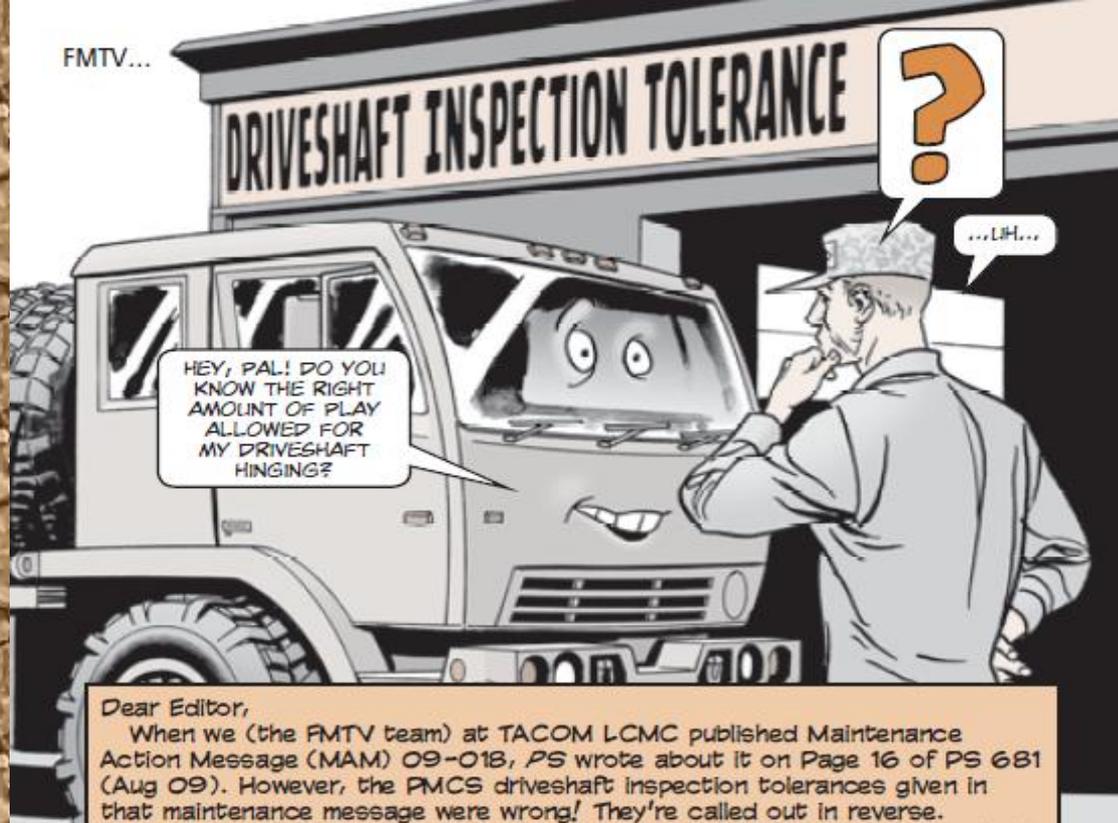
When we (the FMTV team) at TACOM LCMC published Maintenance Action Message (MAM) 09-018, *PS* wrote about it on Page 16 of *PS* 681 (Aug 09). However, the PMCS driveshaft inspection tolerances given in that maintenance message were wrong! They're called out in reverse.

*Perform the driveshaft hinging inspection. No more than 0.020 inch of play is allowed. Also, perform the radial end play inspection. No more than 0.006 inch of play is allowed. After the inspection is done, lube your truck's driveshaft universal joints.*
