# POWER STEERING CAP'S A REAL MISHAP!

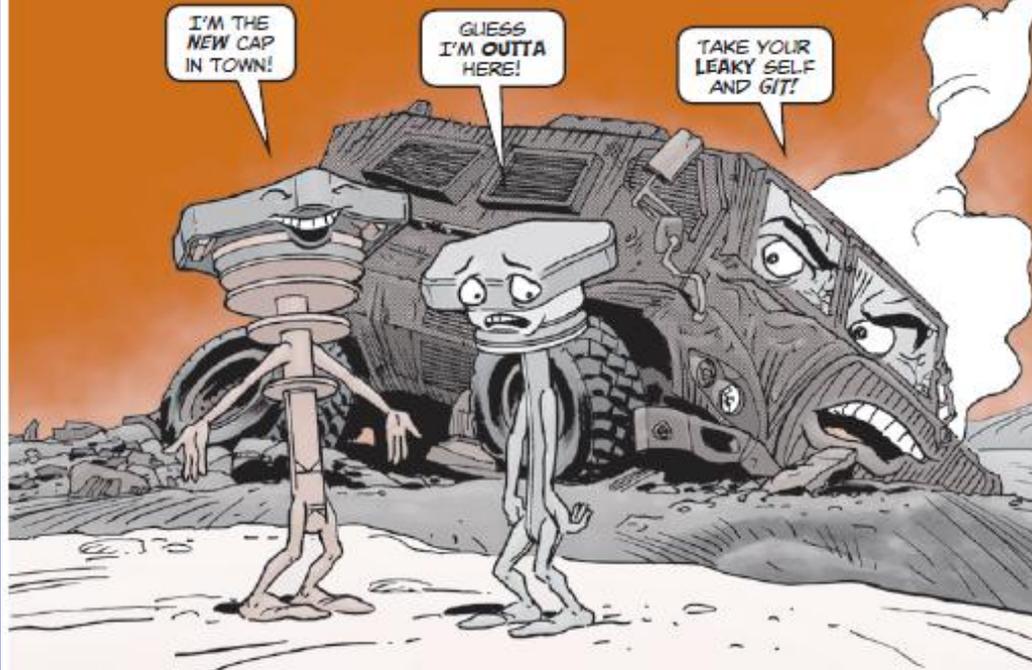
**A** loss of power steering fluid will cause the MaxxPro to steer hard or erratic during operation—or not at all!

The culprit is usually the vehicle's original power steering reservoir cap, NSN 2590-01-556-5316. It's a known leaker.

To stop fluid loss, replace the old cap with a new style cap. The new cap, NSN 6680-20-006-4251, has three baffles on its dipstick that keep fluid from seeping past the cap.

So eyeball the cap you have on your MaxxPro. If it's the old-style cap, replace it now.
