DON'T SHRUG OFF SHROUD

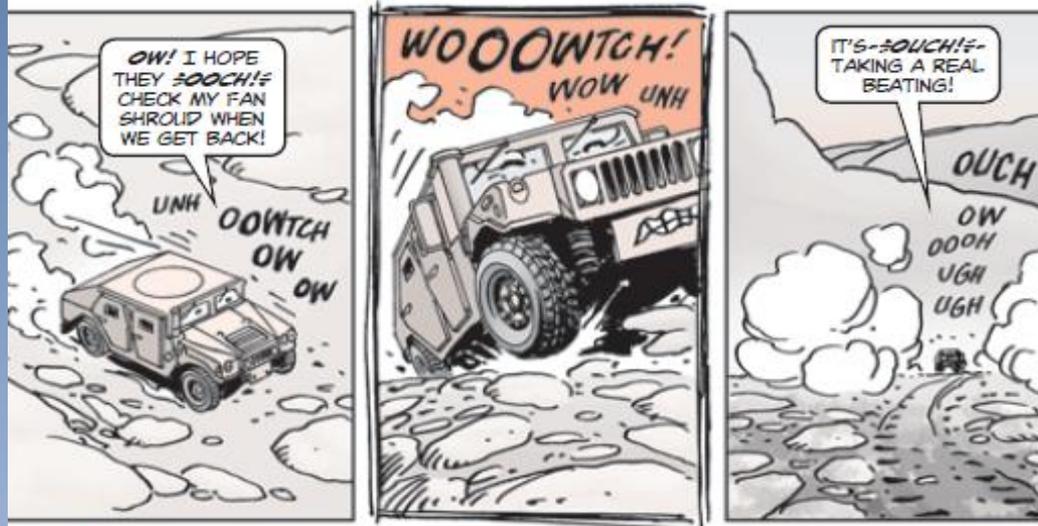
Drivers, if you've been doing a lot of cross-country driving lately, the fiberglass fan shroud in your HMMWV may have taken a beating.

The bottom of the shroud gets hit by brush, rocks, tree stumps and road debris. That cracks the shroud and can even bend it inward enough that it gets hit by the fan blades. That means even more shroud cracks and possibly a shattered blade.

So take a look at the bottom of the shroud after you've been operating in the boonies. If you spot problems, tell your mechanic.

He'll repair minor damage with the fiberglass repair kit, NSN 2090-00-372-6064. Cracks and breaks that can be fixed without removing the shroud are considered minor. Major damage means he'll have to replace the shroud following the instructions that start on Page 3-110 of TM 9-2320-280-20-2 (Jan 96 w/Ch 3).
