Alternative *SHOCK* for Armor

If your unit has up-armored M915A3 trucks, you may have already noticed that the front shocks, NSN 2510-01-479-1515, don't handle the added weight of the armor too well.

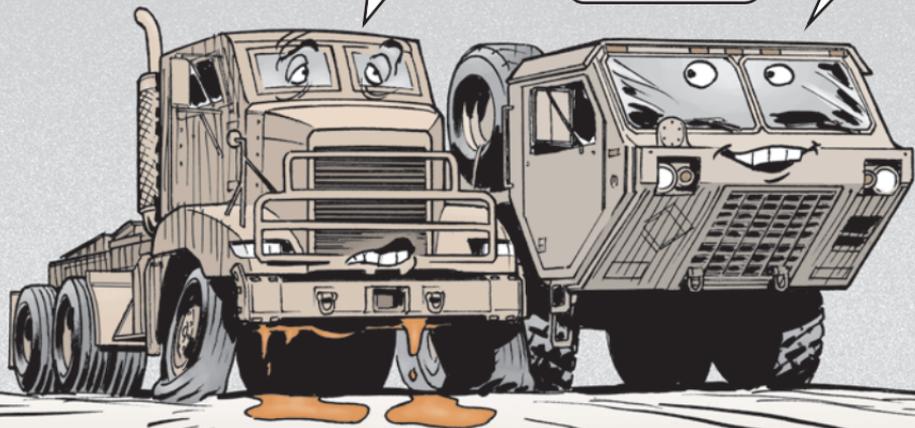
ALL THIS WEIGHT FROM MY ADDED ARMOR HAS RUINED MY FRONT SHOCKS.

NOW I'LL NEED THEM REPLACED.

Some Soldiers have found busted shocks, leaking fluid and worn tires that need replacing too soon! But you can stop this.

MAKE SURE THEY REPLACE 'EM WITH HEMTT SHOCKS!

One unit at Ft Campbell discovered that installing HEMTT shocks, NSN 2510-01-132-4983, fixed this problem. This NSN brings the upper and lower bushings and the shock. It fits right on, too, so no mods are needed. Plus, TACOM LCMC approves this.

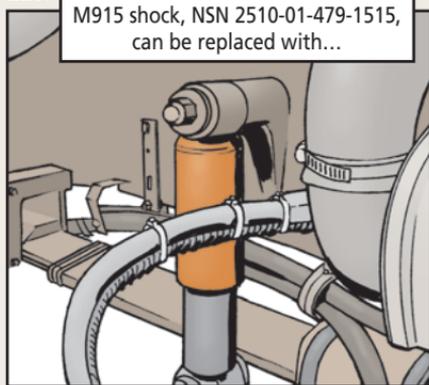
M915 shock, NSN 2510-01-479-1515, can be replaced with...

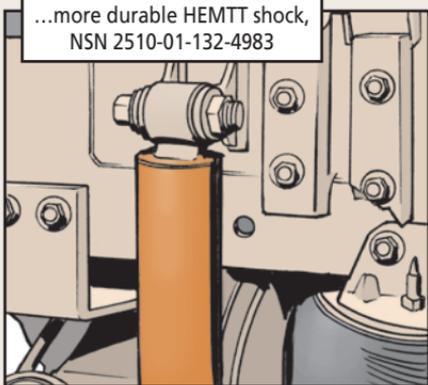
...more durable HEMTT shock, NSN 2510-01-132-4983
